TEST RESULTS REPORT AND DESIGN TECHNOLOGY DEVELOPMENT REPORT - HLH/ATC
HIGH-SPEED TAPERED ROLLER BEARING
DEVELOPMENT PROGRAM

Boeing Vertol Company

Army Air Mobility Laboratory

June 1974

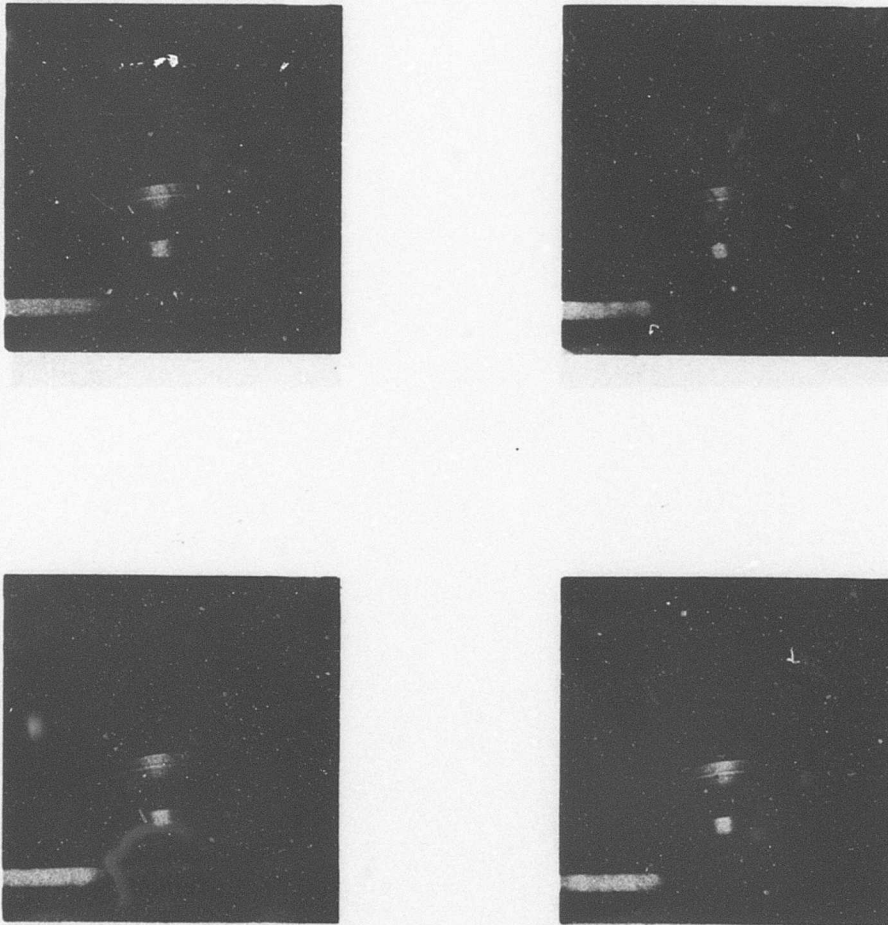
Figure 68. Simulated XC11437 Cone at 3000 rpm--Angle and Length of Oil Hole - 75° , 0.5 Inch; Oil Flow Rate - 6 Pints per Minute.

Figures 8 through 13 are drawings of the simulated cones tested, and Appendix VIII contains high-speed strobe light photographs, showing the oil distribution at the cone rib interface for each test. A brief description of the test parameter is given on each photograph. The photographs are grouped

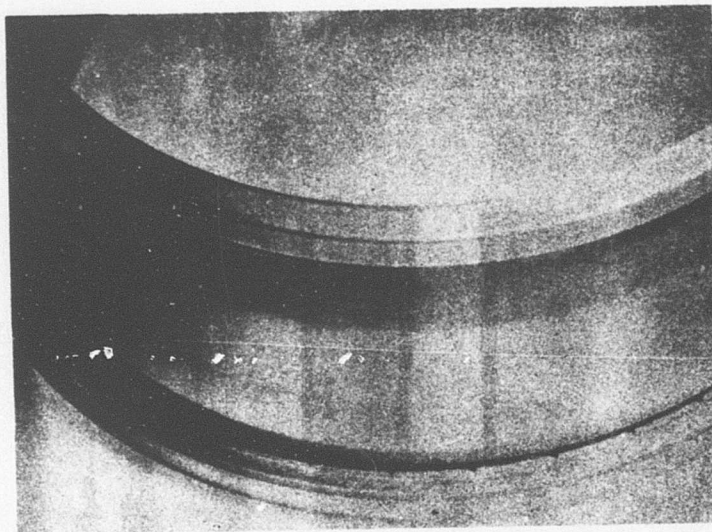
Figure 98. View of Cone Race Surface - Bearing S/N 73-69
(Note: Debris Damage on Race Surface).

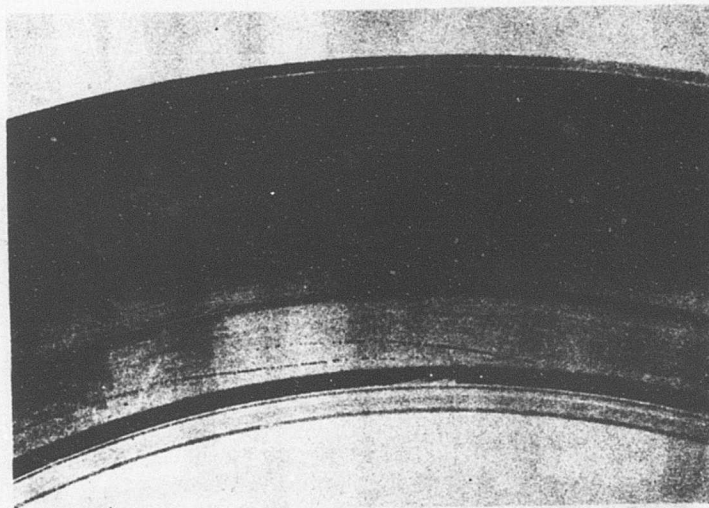
Figure 99. View of Cup Race Surface - Bearing S/N 73-69
(Note: Debris Damage on Race Surface).

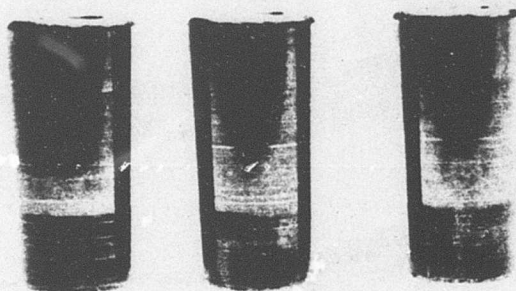
Figure 100. View of Rollers - Bearing S/N 73-69
(Note: Several Pits on Center Roller).
